試驗報告

報告編號：TK-18-03357

TEST REPORT

REPORT NO : TK-18-03357A

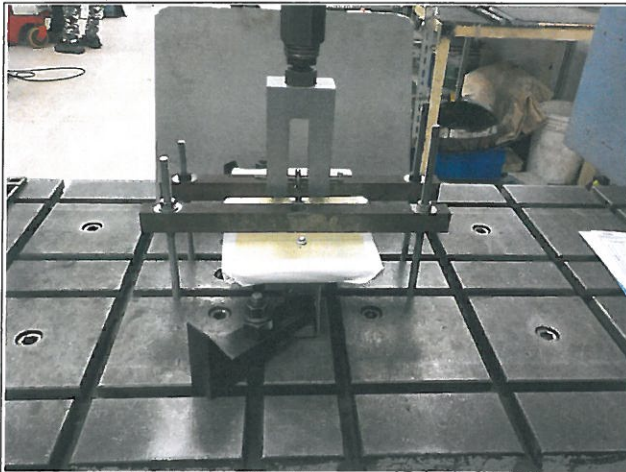
委託單位：石中劍股份有限公司
 產品名稱：石中劍高張力螺絲
 產品型號：M6,開孔徑 10.5mm
 收件日期：107年06月22日
 試驗日期：107年06月22日~107年06月28日
 試驗方法：依顧客指定方式如相片所示,均勻施加荷重抗拉至破壞為止(試驗速率：10mm/min)
 備註：1.以上資料由顧客提供(收件及試驗日期除外)
 2.除非另有說明,此報告結果僅對測試之樣品負責
 未經本公司事先書面同意,此報告不可部分複製

抗拉試驗

試件名稱	最大抗拉荷重
----	kgf
石中劍高張力螺絲, M6,開孔徑 10.5mm	1341

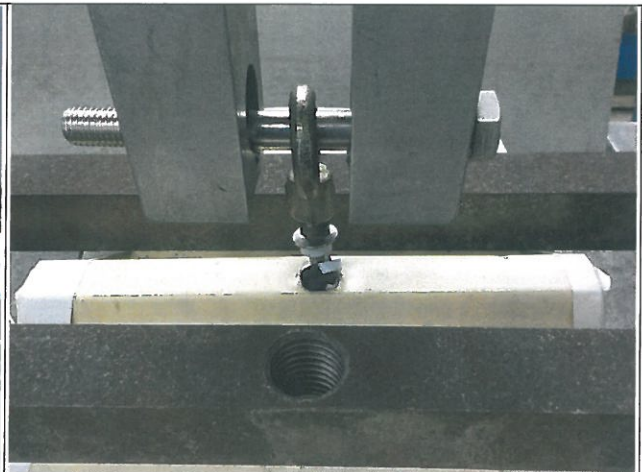
試驗後樣品

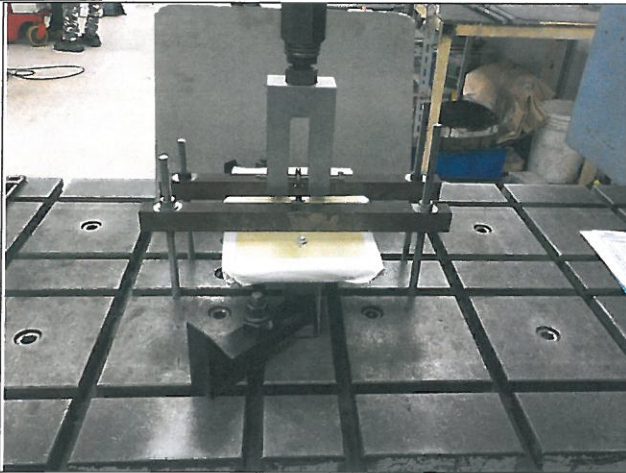
Test Photo

Tensile test

Applicant: STRONGEN solar mounting system Co.,Ltd
 Product Description: STRONGEN Heavy shield anchor
 Product Type: M6 , drilling 10.5mm
 Received Date: Jun. 22, 2018
 Tested Date: Jun. 22, 2018~Jun. 28, 2018
 Test Method: Such as the photo shows, a uniform rate tensile test until the sample damage (test rate : 10 mm/min)
 Remark: The information mentioned in the above section is provided by Client (Exclude Date of Sample Received and Date of Testing)

Sample Name.	Tensile load
----	kgf
STRONGEN Heavy shield anchor , M6 , drill hole 10.5mm	1341

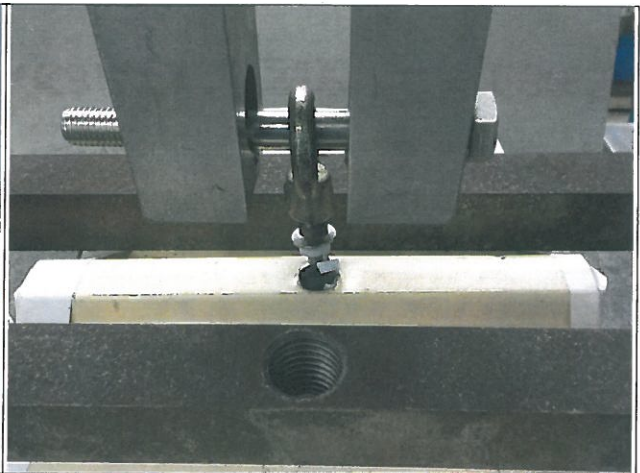
After Test Photo
